NAUGATUCK RIVER BASIN PLYMOUTH, CONNECTICUT

# PLYMOUTH RESERVOIR DAM CT 00286

PHASE I INSPECTION REPORT
NATIONAL DAM INSPECTION PROGRAM

**MAY 1981**

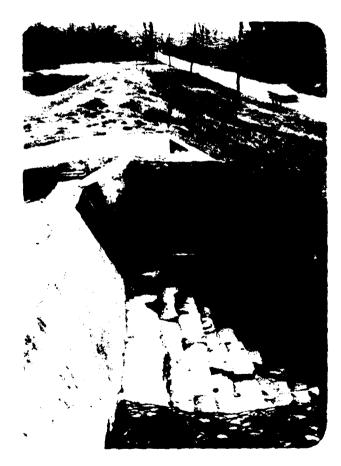
#### PHOTO NO. 8

The overflow spillway consists of a concrete and stone massonry structure, Photos 7 and 8. The lower portion of the spillway is constructed of stepped stone masonry with the joints plastered with mortar. The upper portion and weir are constructed of concrete. The concrete appears to be in good condition with some minor spalling of the concrete training walls below the waterline. The left end of the spillway crest was wet indicating that this end may be slightly lower in elevation. At the right end of the spillway, a puddle on the stone masonry at the base of the concrete section may indicate seepage between the concrete and stone masonry. The concrete training walls were lined with stone filled gabions when the downstream slopes were flattened and drainage blankets installed. A filter fabric is present between the embankment and the gabions. The gabions appear to be in good condition, Photos 7 and 8, with no settlement observed behind them. The installation of the gabions reduced the spillway length from 40 feet to 31.7 feet.

LEFT SPILLWAY TRAINING WALL.
NOTE REDUCTION OF SPILLWAY
LENGTH DUE TO LOCATION OF
GABIONS INSIDE OF CONCRETE
TRAINING WALLS.
